# Extravehicular Activity Operations and Advancements

## Spacewalking: Extravehicular Activity

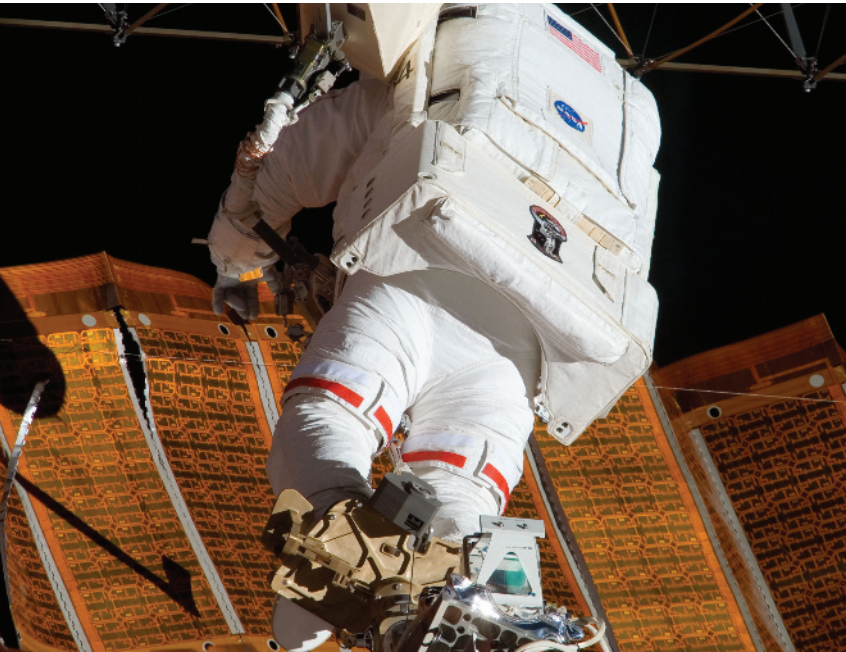
*Contingency extravehicular activity: Astronaut Scott Parazynski, atop the Space Station Robotic Arm and the Shuttle Robotic Arm extension, the Orbiter Boom Sensor System, approaches the International Space Station solar arrays to repair torn sections during STS-120 (2009).*

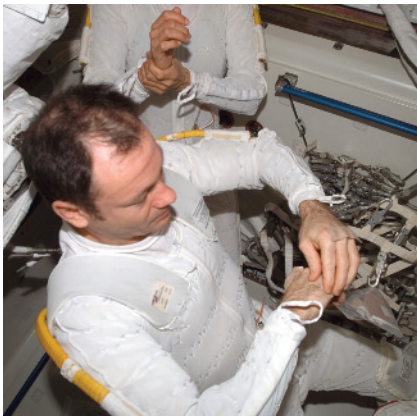
## Extravehicular Mobility Unit

*February 8, 2007: Astronaut Michael Lopez-Alegria, International Space Station Expedition 14 commander, dons a liquid cooling and ventilation garment to be worn under the extravehicular mobility unit. Here, he is preparing for the final of three sessions of extravehicular activity (EVA) in 9 days.*

ventilate the crew member. The shuttle EVA suit improved on the Apollo design by removing the water tubes from the body of the suit and putting them in a separate garment—the liquid cooling ventilation garment. This garment was a formfitting, stretchable undergarment (think long johns) that circulated water and oxygen supplied by the Primary Life Support System through about 91 m (300 ft) of flexible tubing. This component of the suit was easily replaceable,

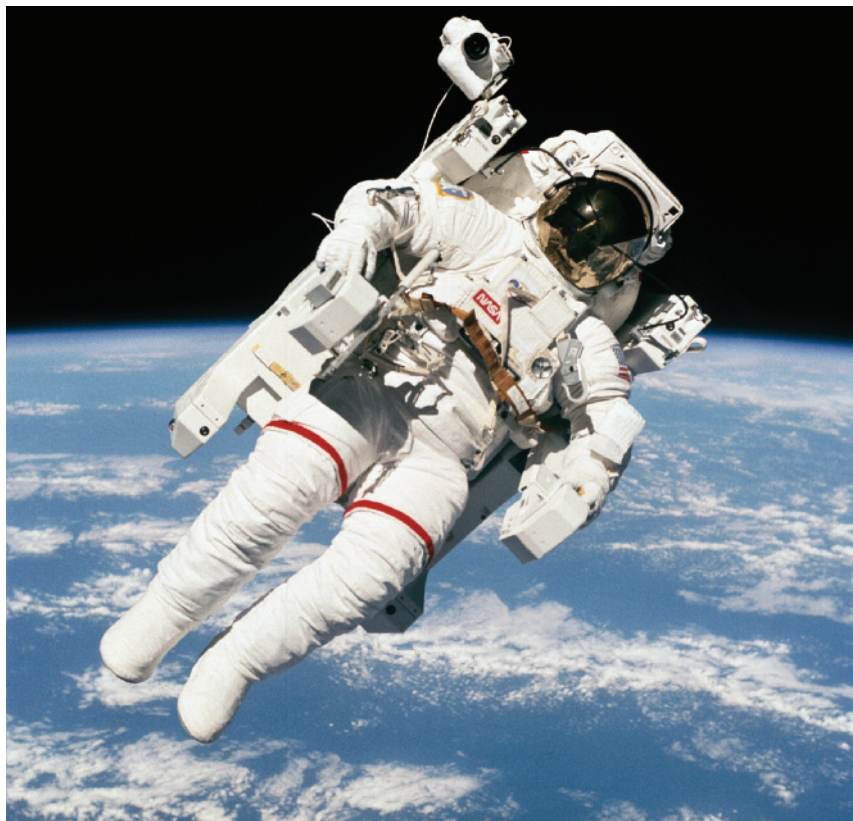
*Astronaut Bruce McCandless on STS 41B (1984) in the nitrogen-propelled manned maneuvering unit, completing an extravehicular activity. McCandless is floating without tethers attaching him to the shuttle.*

that would be used on upcoming spacewalks to retrieve and repair satellites. One of the highlights was a test of the manned maneuvering unit, a jet pack designed to allow EVA crew members to fly untethered, retrieve satellites, and return with the satellite to the payload bay for servicing. The manned maneuvering unit allowed an EVA crew member to perform precise maneuvering around a target and dock to a payload in need of servicing.

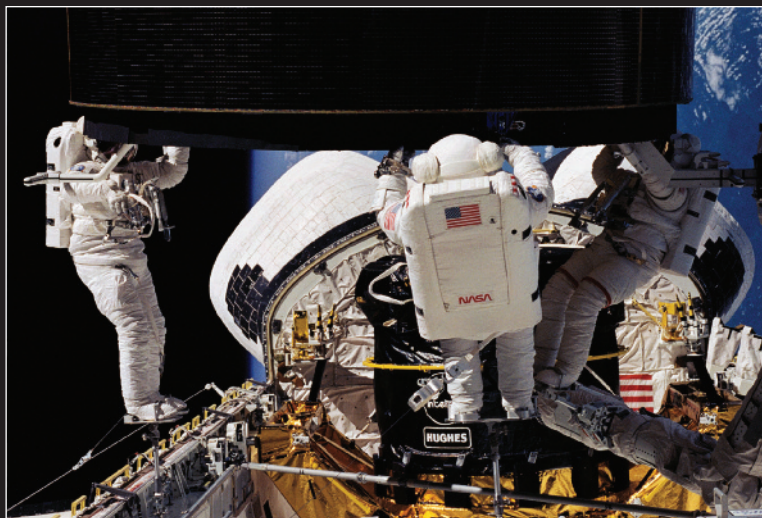
## **Three Spacewalkers Capture Satellite**

*Astronauts Rick Hieb on the starboard payload bay mounted foot restraint work station, Bruce Melnick with his back to the camera, and Tom Akers on the robotic arm mounted foot restraint work station—on the backside of the Intelsat during STS-49 (1992).*

STS-49 significantly impacted planning for future EVAs. It was the most aggressive EVA flight planned, up to that point, with three EVAs scheduled. Engineers designed a bar with a grapple fixture to capture Intelsat and berth it in the payload bay. The data available on the satellite proved inadequate and it was modeled incorrectly for ground simulations. After two EVA attempts to attach the capture bar, flight controllers looked at other options.

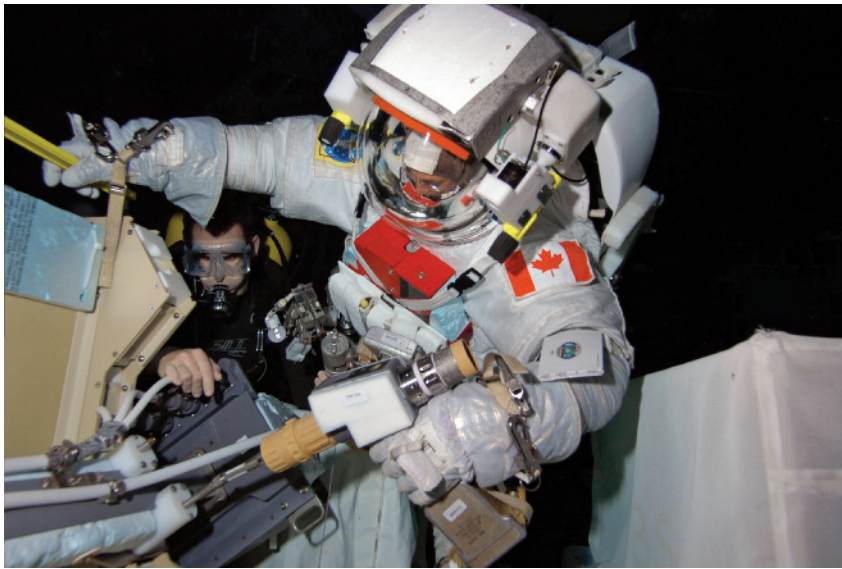
*Astronaut Dafydd Williams, STS-118, representing the Canadian Space Agency, is wearing a training version of the extravehicular mobility unit spacesuit while participating in an underwater simulation of extravehicular activity in the Neutral Buoyancy Laboratory near Johnson Space Center. Scuba-equipped divers are in the water to assist Williams in his rehearsal, intended to help prepare him for work on the exterior of the International Space Station. Observe Williams holding the Pistol Grip Tool in his left hand with his shoulder extended. This position causes shoulder pain during training in neutral buoyancy.*

The gravity environment of the water tank also contributed to shoulder injuries—a chronic issue, especially in the latter part of the program. Starting in the mid 1990s, several crew members experienced shoulder injuries during the course of their EVA training. This was due to a design change made at that time to the extravehicular mobility unit shoulder joint. The shoulder joint was optimized for mobility, but designers noticed wear in the fabric components of the original joint. To avoid the risk of a catastrophic suit depressurization, NASA replaced the joint with a scye bearing that was much less subject to wear but limited to rotation in a single plane, thus reducing the range of motion. The scye bearing had to be placed to provide good motion for work and allow the wearer to don the extravehicular mobility unit through the waist ring (like putting on a shirt),

which placed the arms straight up alongside the head. Placement of the shoulder joint was critical to a good fit, but there were only a few sizes of upper torsos for all crew members. Some crew members had reasonably good fit with the new joint, but others suffered awkward placement of the ring, which exerted abnormal forces on the shoulders. This was more a problem during training, when stress on the shoulder joint was increased due to gravity.

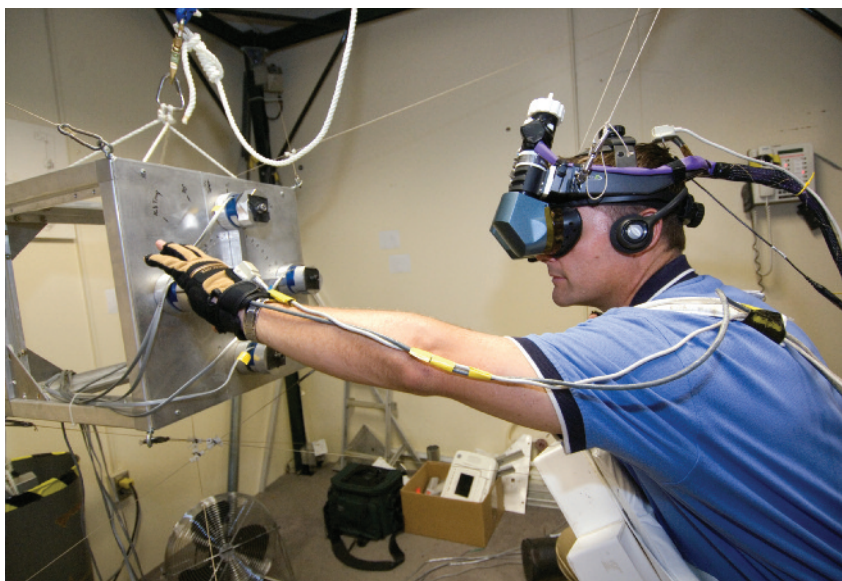
*Astronaut Douglas Wheelock, STS-120 (2007), uses virtual reality hardware in the Space Vehicle Mockup Facility at Johnson Space Center to rehearse some of his duties on the upcoming mission to the International Space Station.*

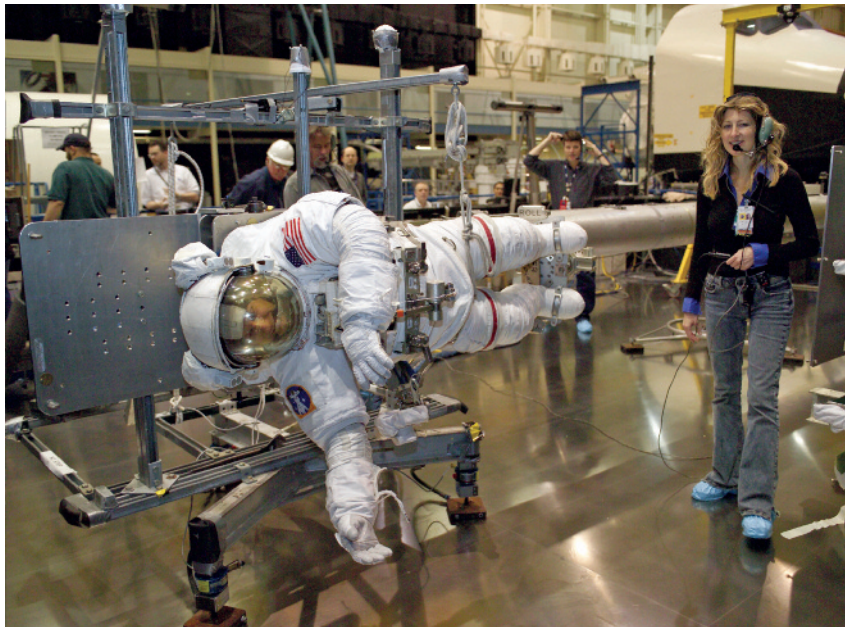
*Astronaut Piers Sellers, STS-121 (2006), wearing a training version of the extravehicular mobility unit, participates in an extravehicular activity simulation while anchored on the end of the training version of the Shuttle Robotic Arm in the Space Vehicle Mockup Facility at Johnson Space Center (JSC). The arm has an attached 15-m (50-ft) boom used to reach underneath the Orbiter to access tiles. Lora Bailey (right), manager, JSC Engineering Tile Repair, assisted Sellers.*
